UNDERWATER BRIDGE INSPECTION REPORT

STRUCTURE NO. 30501

RUM RIVER

DISTRICT 3 - ISANTI COUNTY

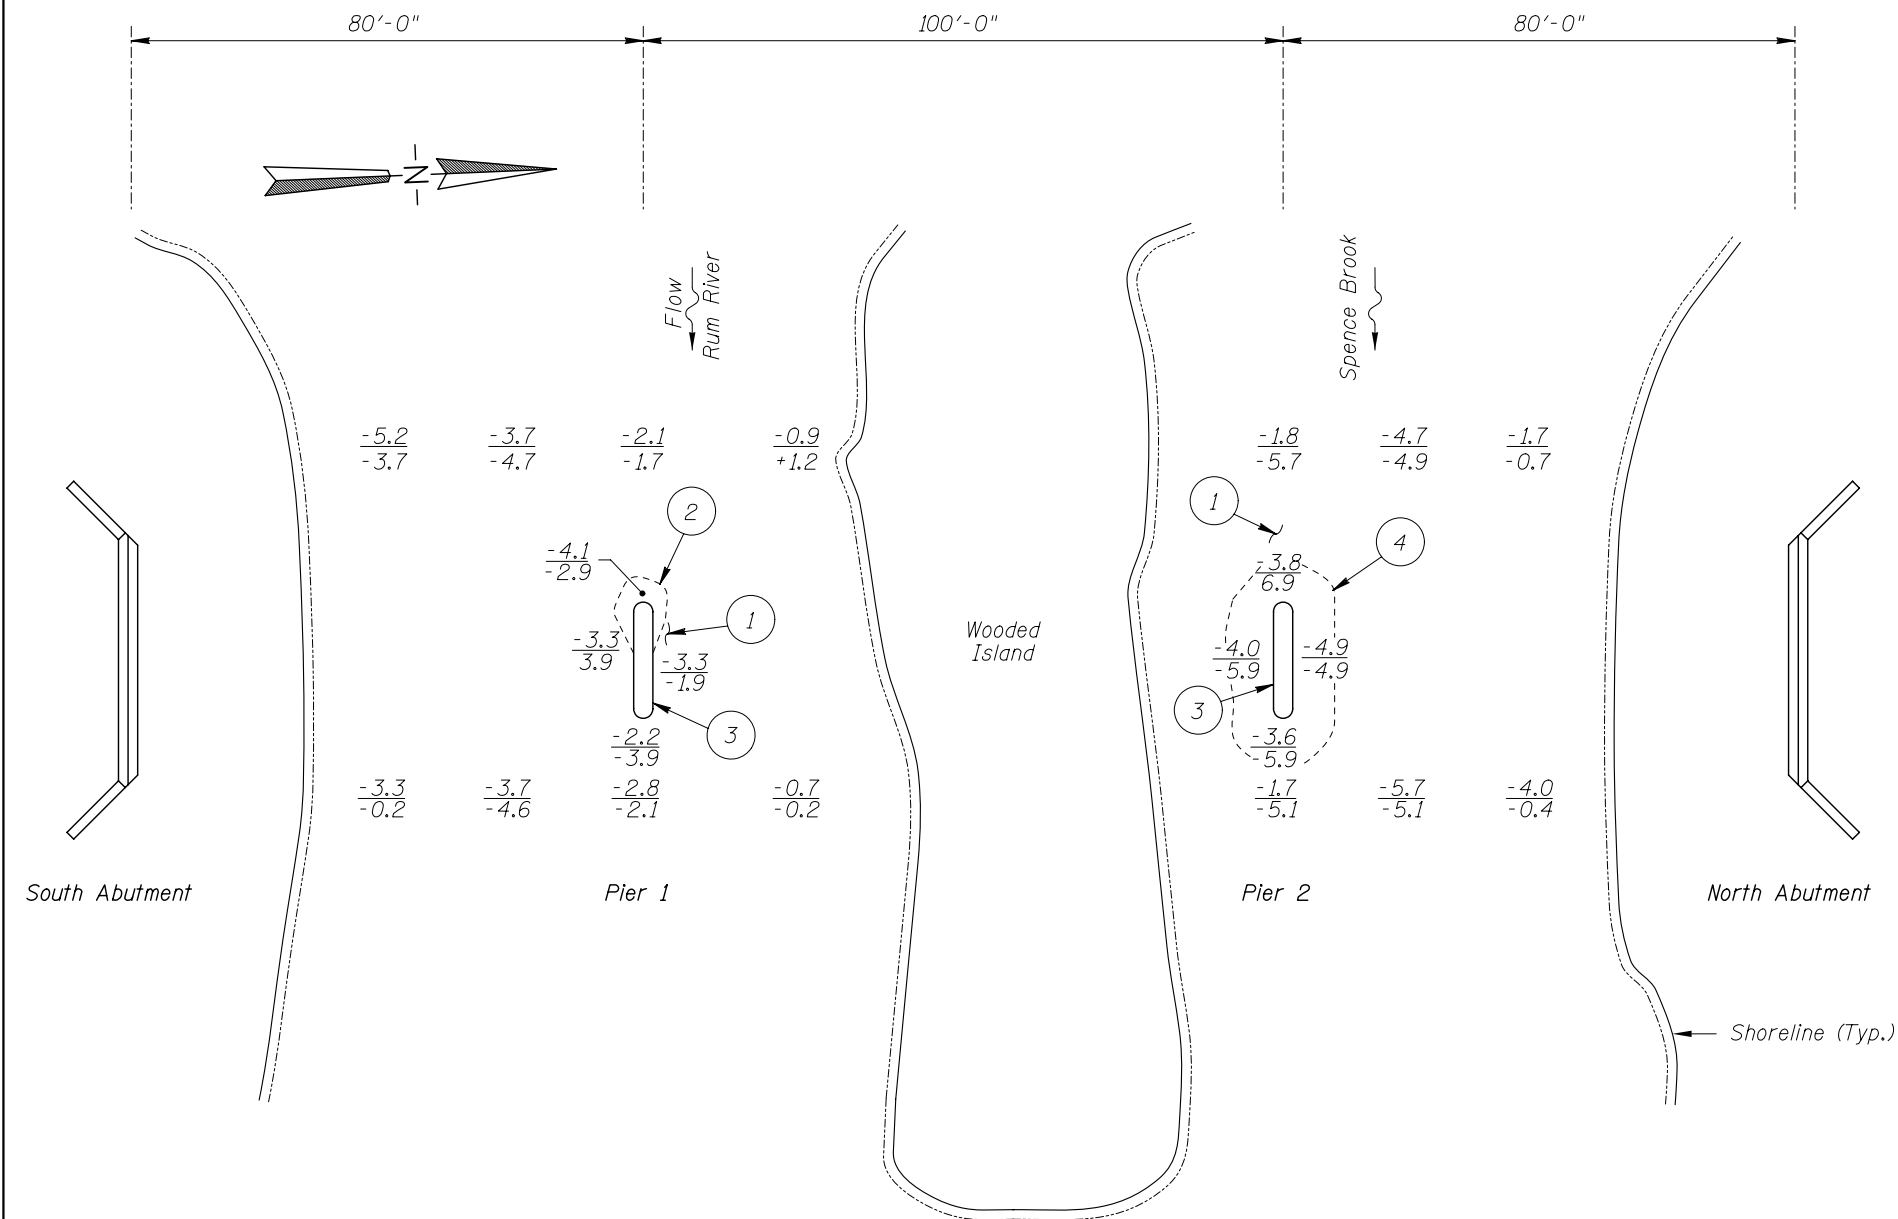
INSPECTION AND SOUNDING PLAN

- The channel bottom consisted of silty sand with up to 1 foot of probe rod penetration.
- A scour pocket, 3 feet in radius by 2 feet deep, was observed at the upstream nose of Pier 1 and extended along the pier shaft to the upstream quarter points.
- A band of light scaling was observed around the entire perimeter of both piers and extended from the channel bottom to 2 feet above the waterline with up to 1/4 inch of penetration.
- A scour pocket, 3 feet in radius by 2 feet deep, extended around the entire pier shaft at Pier 2.
